Outstanding Projects of 2004

Thomas Fork Stream Bank Stabilization Project

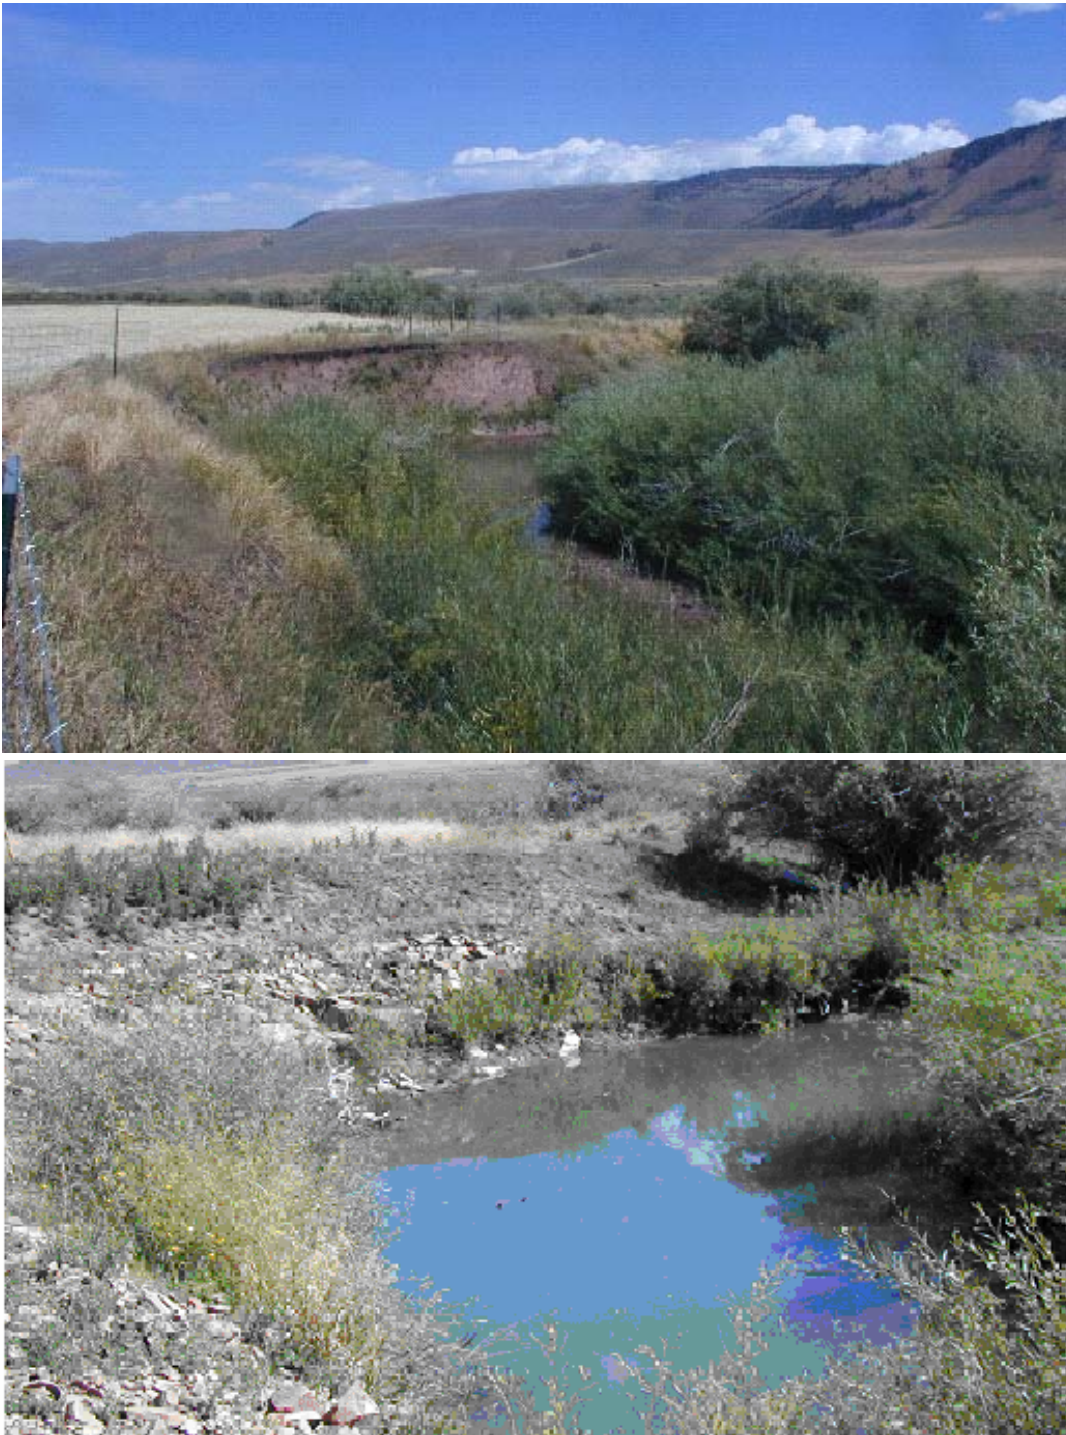
Figure 33. Segment B before construction (above) and six months after construction (below).

Rip-wrap is placed along banks that have been shaped to keep soil in place. This treatment appears to be the most effective method of keeping soil in place until seed can germinate and sprout. Areas of bank that begin to erode after construction are quickly and easily doctored using maintenance rock left on site as per the landowner maintenance agreement.

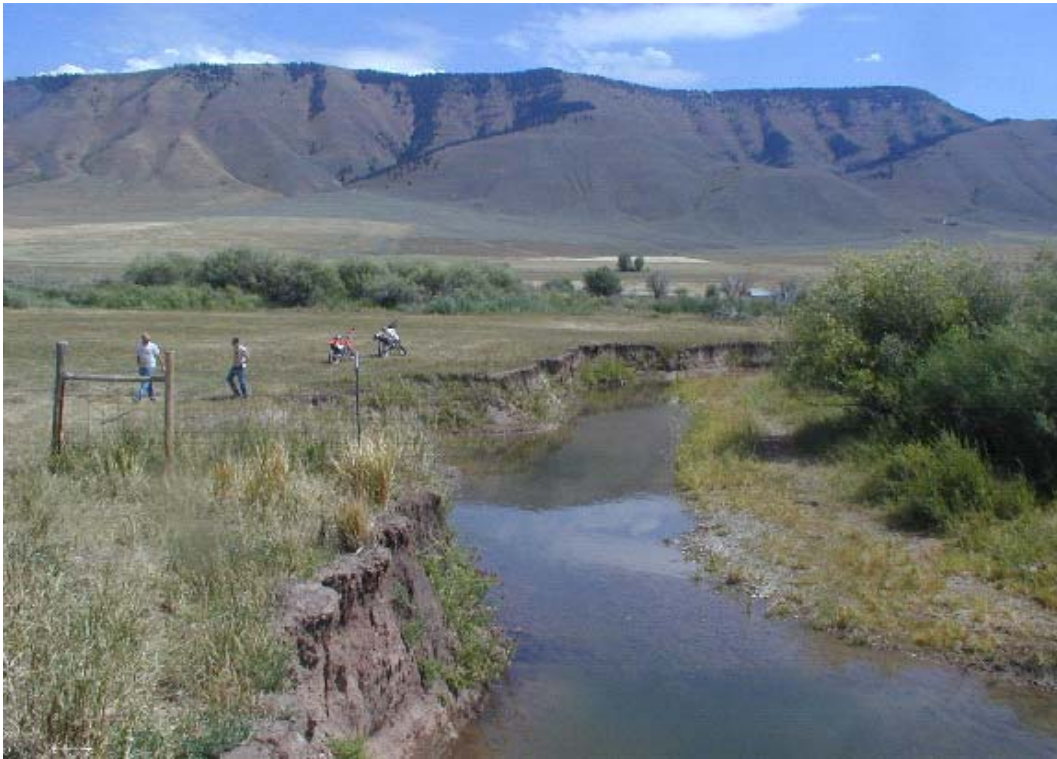
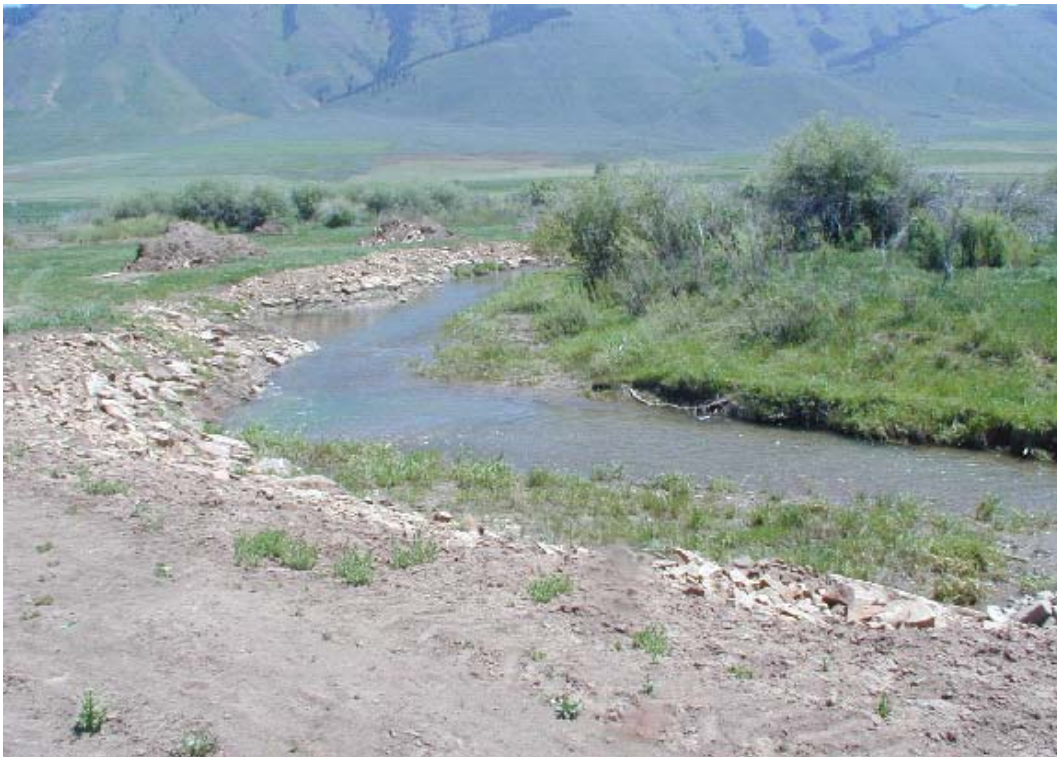
Figure 34. Segment C improvements prior to construction (above) and six months after implementation of BMPs (bottom).

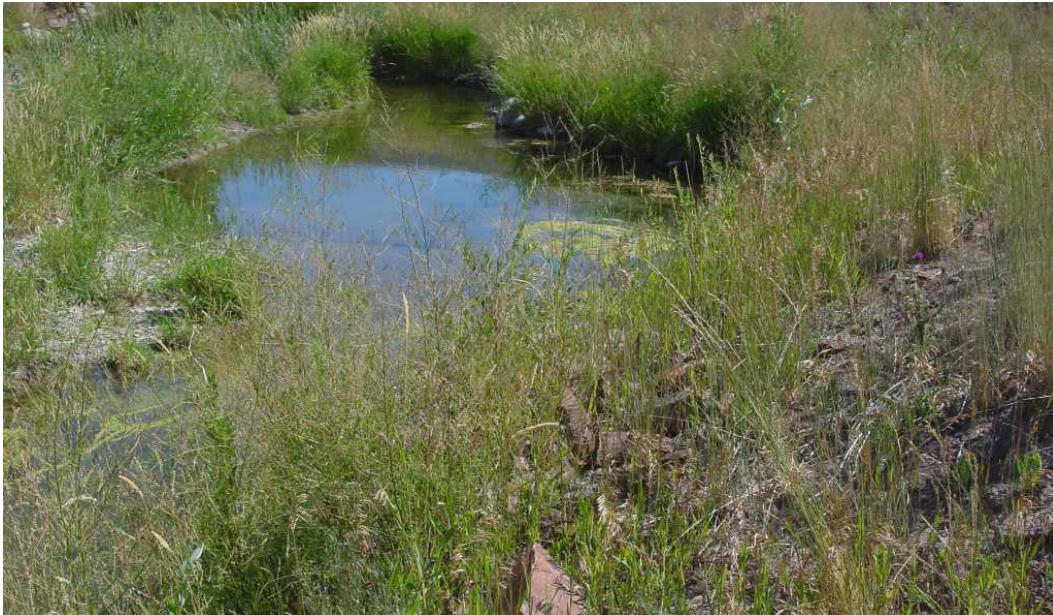
Barbs are used to deflect the flow of the water away from sensitive areas to encourage growth of riparian vegetation. This method is also highly effective in promoting re-growth of riparian vegetation. Rock for the barbs is provided by nearby quarries—a benefit to the project and the local economy. This method provides a very small cost benefit ratio, and it will continue to be used on Thomas Fork. Other benefits produced by implementing barbs include the creation of pool riffle sequences and the reduction of stream width during low flow. Examples of the improvements realized using barbs can be seen in Figure 35.

Figure 35. Illustration of the effectiveness of bank barbs at protecting degraded areas. The emergent vegetation near the bottom of the photo exists on an aggraded gravel bar produced by barb placement upstream.

Indirectly, barbs provide an environment to further accomplish all the goals of stream bank stabilization. The benefits of barbs include increased dissolved oxygen, reduced water temperature, and improved uptake of nutrients.
